Comparing the Alloy NS-05C and Netgear FS608 v2 Switches Using Tcpcmdump

Ana M. Pavlicic

Centre for Advanced Internet Architectures. Technical Report 040329A
Swinburne University of Technology
Melbourne, Australia
apavlicic@swin.edu.au

Abstract- In this technical report, the Alloy NS-05C and Netgear FS608 v2 8-port switches are tested using a SmartBits2000 and Tcpcmdump. The purpose of these tests is to compare the number of errors that occur on the backplane of each switch and observe these results through Tcpcmdump timestamps. The Alloy and Netgear switches are both being used at CAIA for a variety of projects.

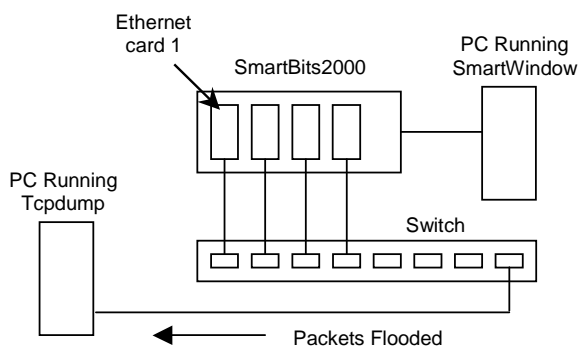
Figure 2: Tcpdump Test Physical Set Up

All three methods of card transmission start were tested with both switches in order to investigate their performance. In these tests, all packets were 1,020bytes plus 4bytes CRC, the utilization was set to 1% on each card and the interpacket gap was set to 200ms. Each card sent 10,000 packets, purposefully configured to be flooded out of all ports by the switch.

Figure 2 shows the physical set up of the Tcpdump tests.

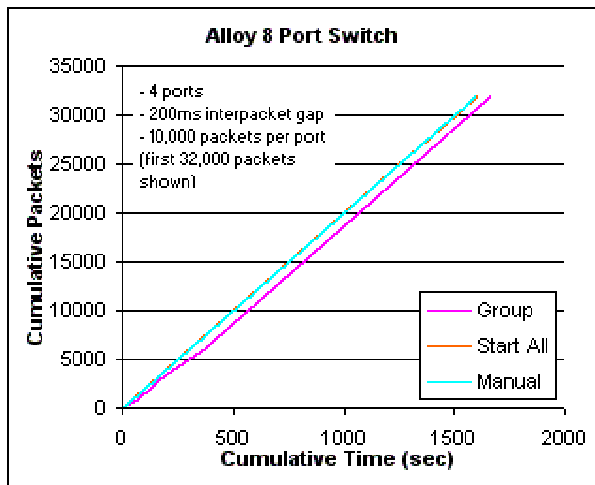
Figure 3: Alloy switch cumulative time vs packets for all start options

The following Figures illustrate packets captured by Tcpcmd indicating where packet loss occurred. Each dot corresponds to one packet captured by Tcpcmd.

It is evident in Figure 3 and Figure 6 that most packets were lost when the Group option was used to begin packet transmission for both switches. The change in slope as seen in the Group graphs is due to fewer packets arriving to Tcpcmd over an interval of time.

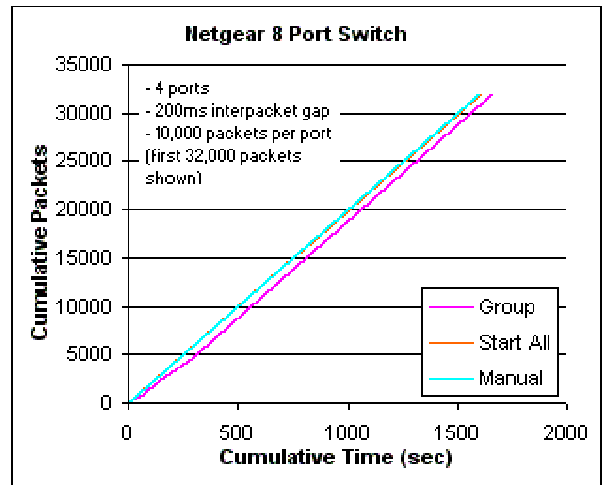
Figure 6: Netgear switch cumulative time vs packets for all start options

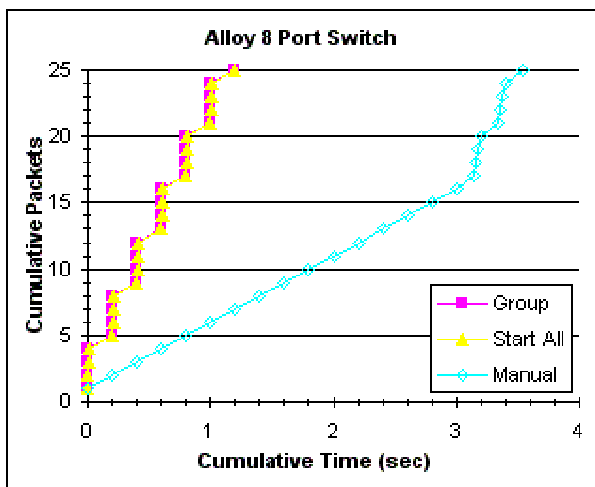
Figure 4: Alloy switch initial packet bursts

Figure 4 and Figure 7 show the close-ups of the beginning of the tests for the Alloy and Netgear switches respectively. We can see that initially, the Manual graphs have a steady gradient as a result of the time between Card 1 and Card 2 being prompted to begin packet transmission. Both the Group and Start All graphs have a continuous pattern from the beginning of transmission.

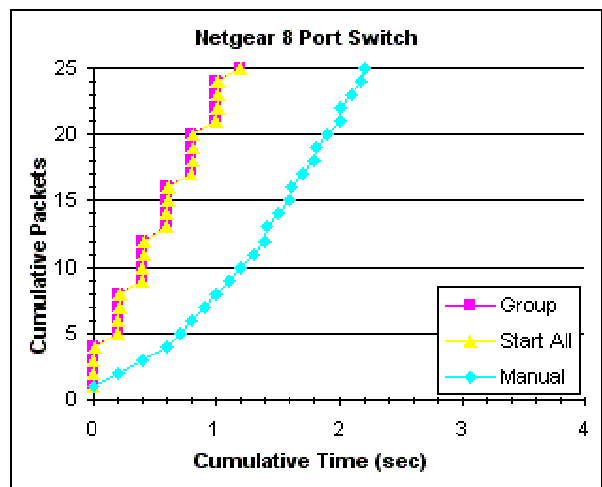
Figure 7: Netgear switch initial packet bursts

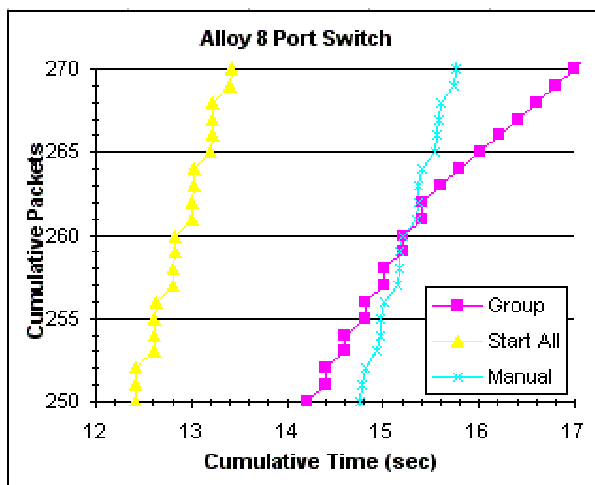
Figure 5: Alloy switch gradient change in Group option due to packet loss

Figure 5 and Figure 8 show packet loss occurring when the Group function was used. In Figure 5 we can see that Tcpdump is only receiving two packets per 200ms between 14.2sec and 15.4sec. This already indicates two packets are lost at each simultaneous SmartBits2000 burst. After this point only one packet is received by Tcpdump, indicating further packet loss at the Alloy switch. Figure 8 shows the same behaviour occurring with the Netgear switch.

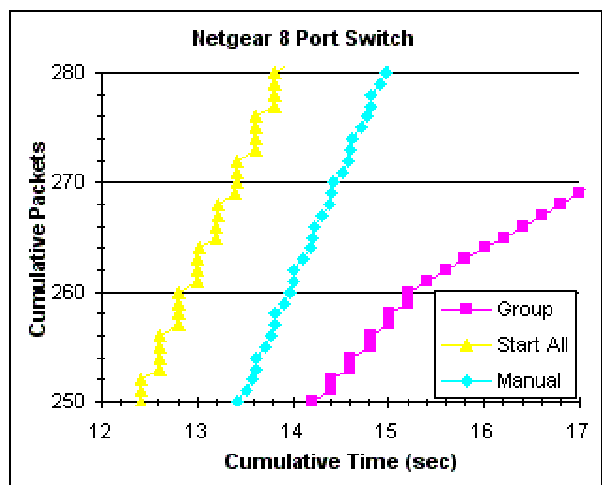
Figure 8: Netgear switch gradient change in Group option due to packet loss
